**Asbestos, Lead, and Hazardous Materials
Pre-demolition Survey Report**

**Palo Alto Veterans Administration Hospital
VA PAHCS, Building 23, Gymnasium and Pool**

Acumen Project No. SMG 2801B

December, 2008

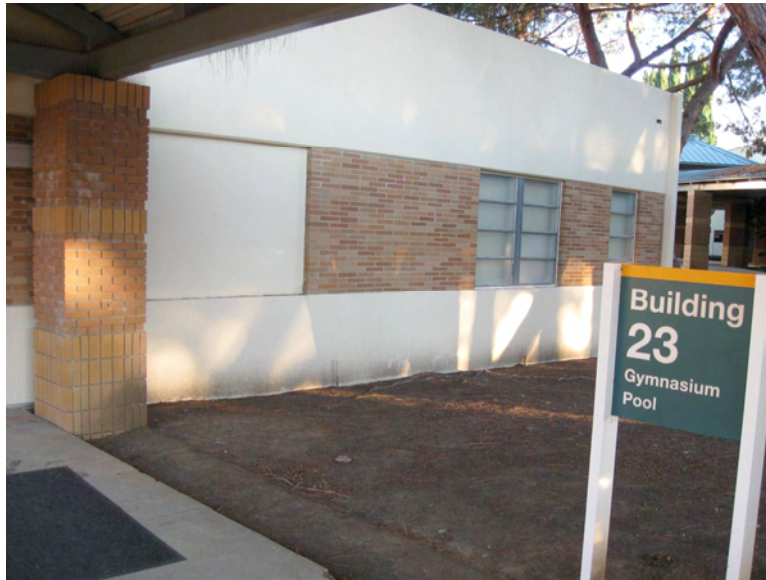
Photo 1

Acumen collected samples of various suspect ACM at the building and determined that ACM is present as reported by the lab. Sample (SMG2801-113008-19A, 19B and 19C) exterior window putty was reported to be <1% chrysotile asbestos or Trace asbestos (Photo 1).

View of building 23 exterior west side with windows and paints

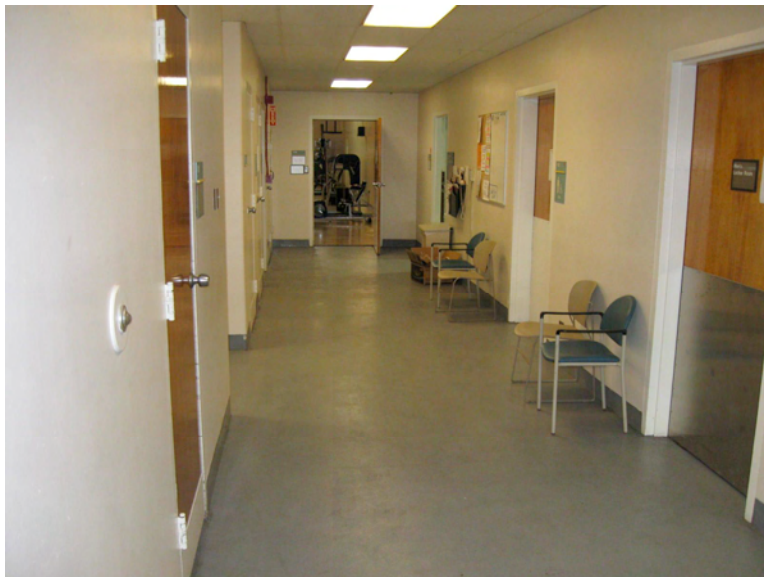
Photo 2

- Off white paint in hallways on concrete walls
Quantity = 1,500 square feet
- Gray paint in hallways on concrete floors and coves
Quantity = 800 square feet
- White paint on exterior concrete walls
Quantity = 28,000 square feet

View main hallway with painted floors and walls

8. None of the lead containing paints observed were found to be deteriorated. Therefore no recommendations are made to stabilize paints (that are deteriorated) or remove lead hazards. Contractors who disturb paints at the buildings need to be informed that lead is present and/or presumed. Lead safe work practices should be implemented by the demolition contractor. Cal-OSHA's lead in construction standard (Title 8 CCR1532.1) requires a contractor to develop and implement a lead compliance plan and use lead safe construction practices. These issues are commonplace since these Cal-OSHA rules have been in effect since 1992 and since lead containing paints are commonly found at buildings constructed prior to 1978.

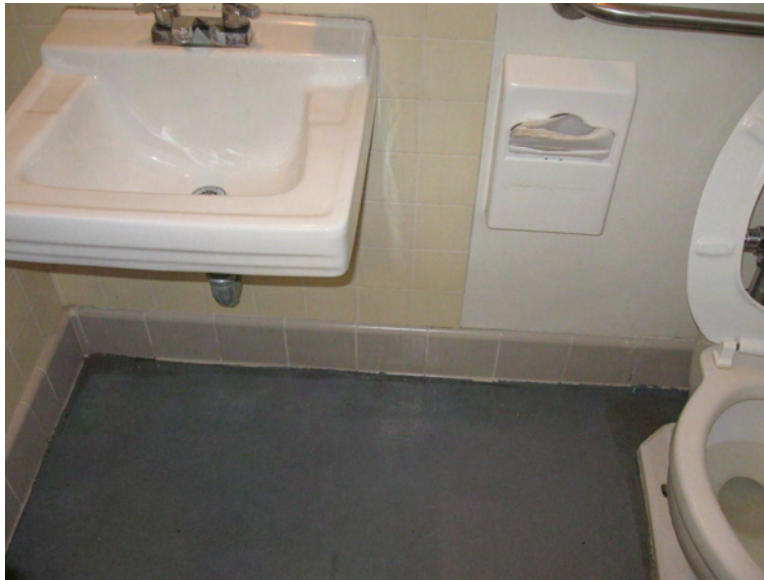
Photo 3

- 5” Gray colored Ceramic tile at cove base, Room 103 restroom
Quantity = 10 square feet
- 4” Light yellow Ceramic tile on walls up to 4 feet height, Room 103 restroom and presumed to be lead containing also at Women’ Locker Room restroom room 101
Quantity = 120 total square feet
- 4” Light green Ceramic tile on walls, up to 4 feet height, Room 102 janitor’s closet
Quantity = 90 square feet
- 6” Cream colored Ceramic tile on wall coves, swimming pool area
Quantity = 300 linear feet

View of Room 103 restroom ceramic tiles

4. It is recommended to segregate the lead containing ceramic tiles removed from other wastes. The waste stream will need to be waste characterized for lead by the California Waste Extraction Test (WET) testing methods.

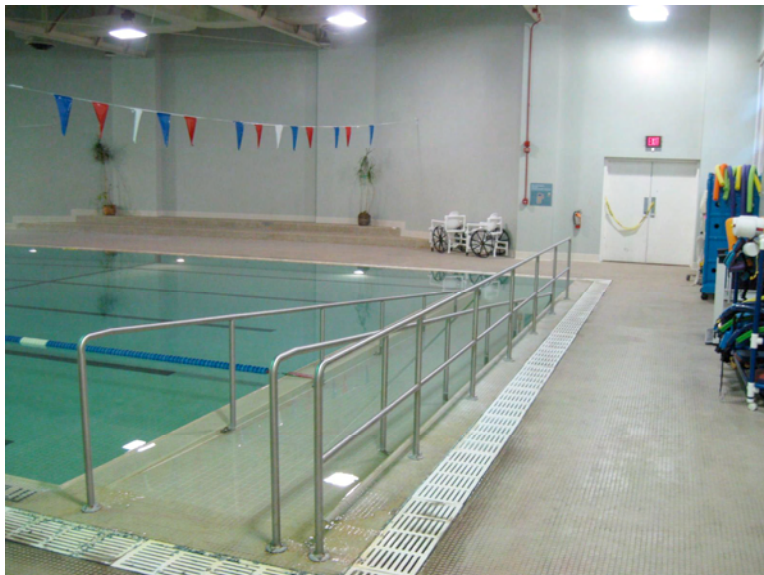
Photo 4

View of pool with ceramic tiles (on far steps in background) and at wall coves

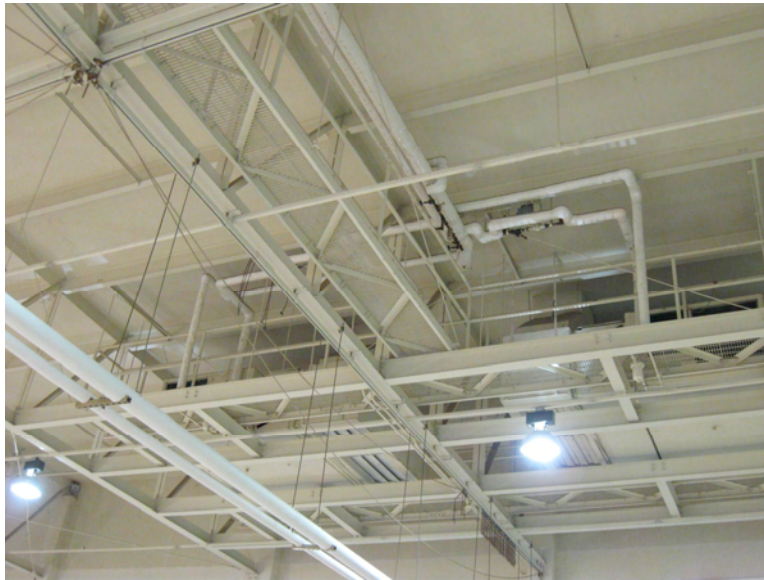
Photo 5

TSI on pipes at the basketball court was found to be a mix of original ACM TSI and replaced fiberglass insulation. Acumen accessed the basketball court cat-walk via a wall mounted ladder to inspect TSI on pipes located along the catwalk. These pipes are associated with HVAC handling units also mounted at the cat walk level. Pipes mounted at this upper ceiling level are presumed to be ACM (PACM) (see photos 5 and 6). At first glance it appears that these pipes are only insulated with fiberglass. However, the original ACM pipe insulation (calcium silicate material) is located underneath a retrofitted jacket of fiberglass insulation.

View of PACM pipe insulation at cat walk/HVAC areas in basketball court, center

5. It is recommended that removal specifications for the TSI be prepared by a certified asbestos consultant. Following abatement work it is recommended to collect asbestos clearance samples.

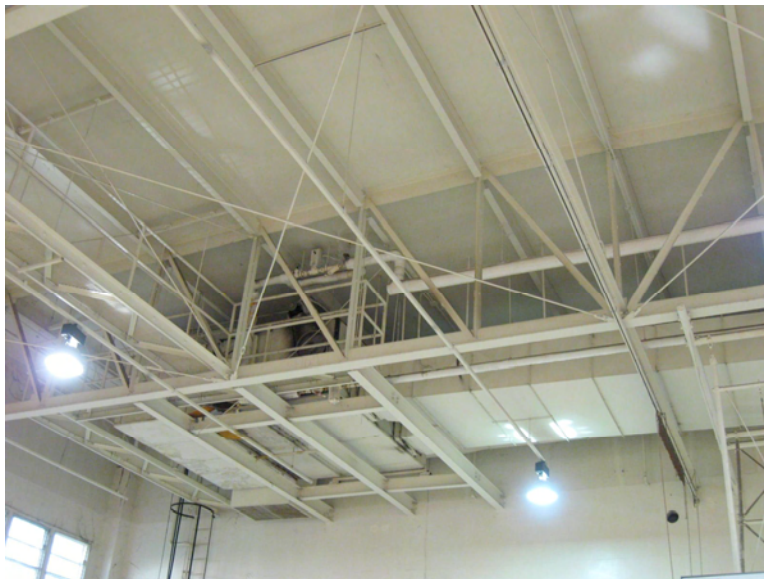
Photo 6

View of PACM pipe insulation at cat walk/HVAC areas in basketball court, at wall ladder

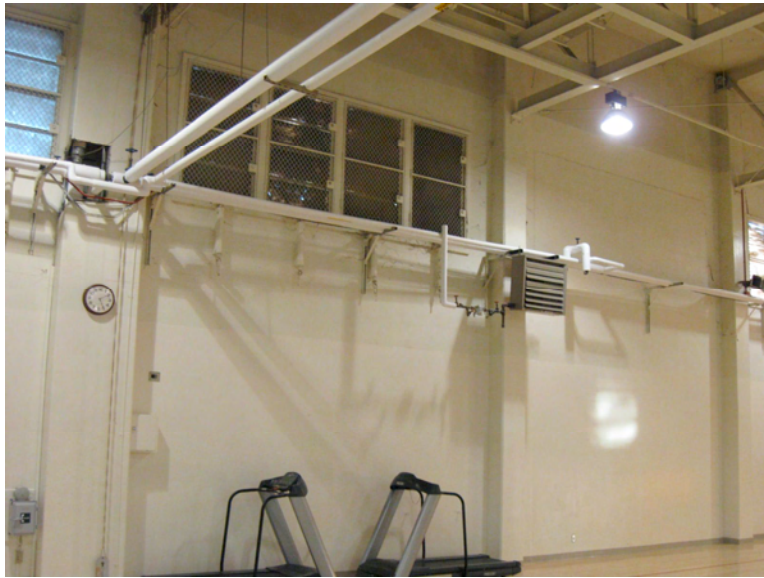
Photo 7

TSI on pipes mounted horizontally, along the lower (approximately 10 foot level) north and south walls of the basketball court were found to be fiberglass only. Presumed ACM pipe insulation (calcium silicate) was also observed at the pool. This material is located at an elevated platform adjoining an HVAC unit. The insulation has suffered minor damage but no debris was observed.

View of fiberglass pipe insulation at lower walls, basketball court

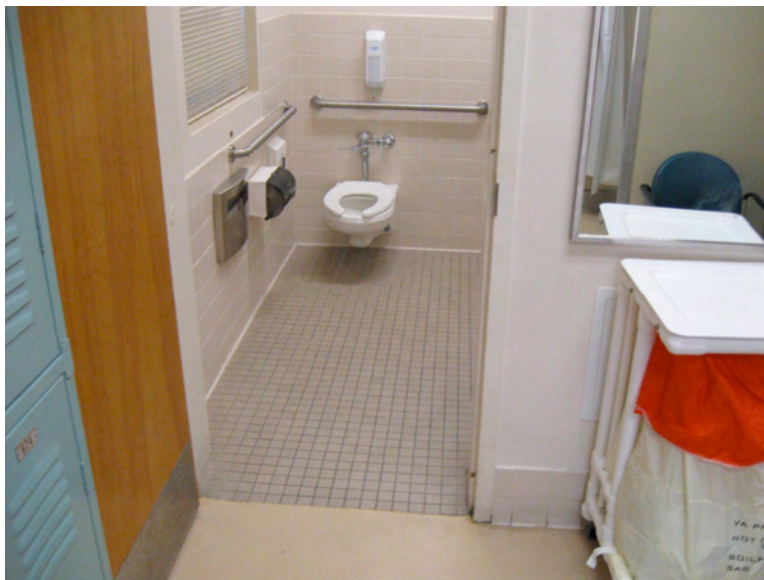
Photo 8

View of presumed lead containing ceramic wall tiles

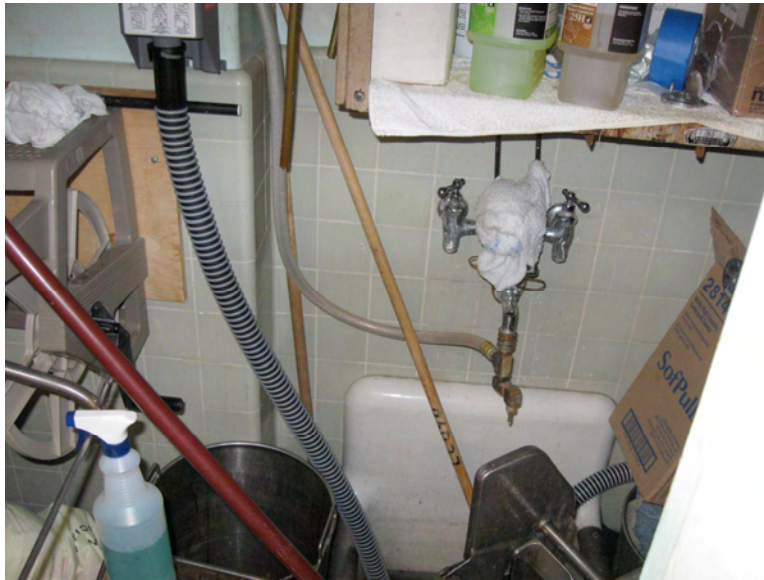
Photo 9

View of lead containing ceramic wall tile at Janitor's closet Room 102

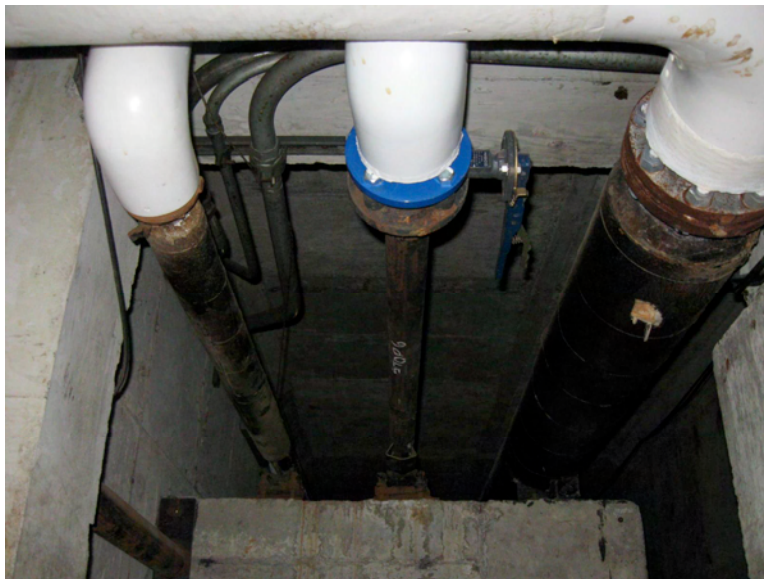
Photo 10

Sample (SMG2801-113008-20A) black tar paper wrap (jacketing) over fiberglass pipe insulation was reported 30% chrysotile asbestos. This material is located in a 25-foot long spur from the main steam tunnel, and is accessed at the Building 23 Boiler Room. The tar paper jacketing is found on both 5” and 12” outer diameter pipes (Photos 9 and 10).

View of ACM black tar paper jacketing over fiberglass insulated pipes in steam tunnel spur
